# FORENSIC ROOF ANALYSIS

Mechanism-Based Evaluation of Observed Conditions

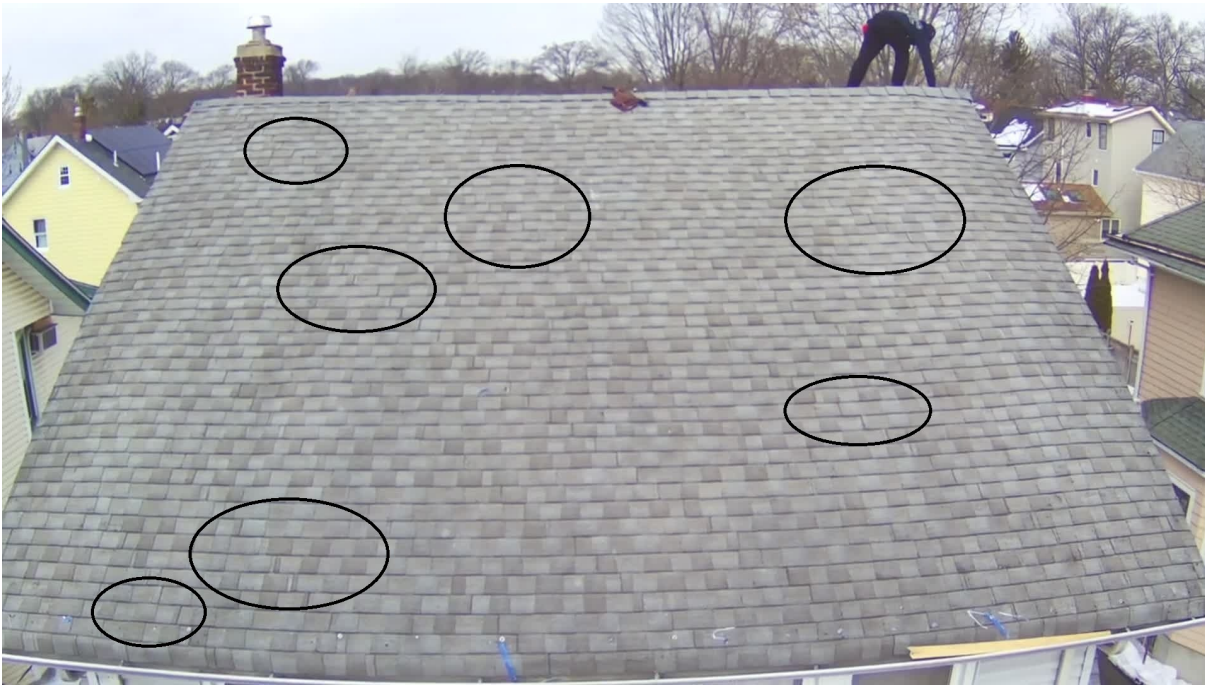
PHOTO 1 OF 7: continuities\_2026020613013921.jpg

**Primary Damage Location:** Roof field

**Mechanism(s):**

Predominant: Wind uplift

Secondary: Not observable

**Evidence:**

- Distributed out-of-plane shingle tab elevation
- Repetitive pattern of shingle lifting across the roof field
- Subtle shadow lines indicating shingle displacement

Conclusion: Observed conditions are most consistent with Wind uplift associated with loading, based on distributed out-of-plane shingle tab elevation, as reflected in a repetitive pattern across the roof field.

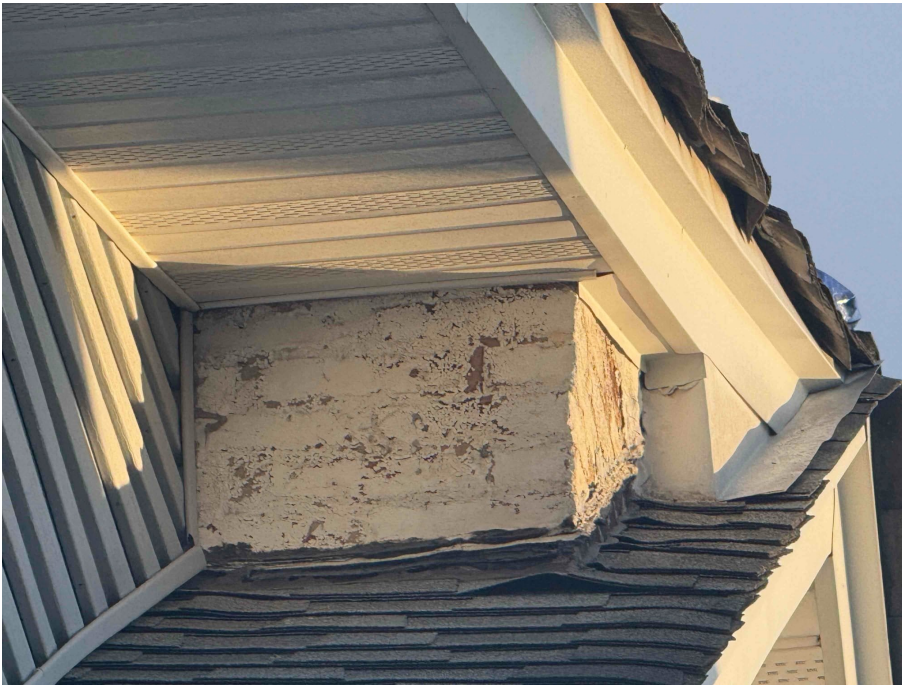
PHOTO 2 OF 7: pjnew2.jpg

**Primary Damage Location: Roof-to-masonry interface****Mechanism(s):**

Predominant: Wind uplift

Secondary: Structural movement

**Evidence:**

- Material loss and out-of-plane displacement of multiple shingle courses at the roof-to-masonry interface.
- Distorted and separated flashing at the interface with the masonry element.
- Step-pattern displacement and misalignment of shingle courses.

Conclusion: Observed conditions are most consistent with Wind uplift associated with loading, based on material loss and out-of-plane shingle displacement, as reflected in step-pattern displacement across the roof-to-masonry interface.

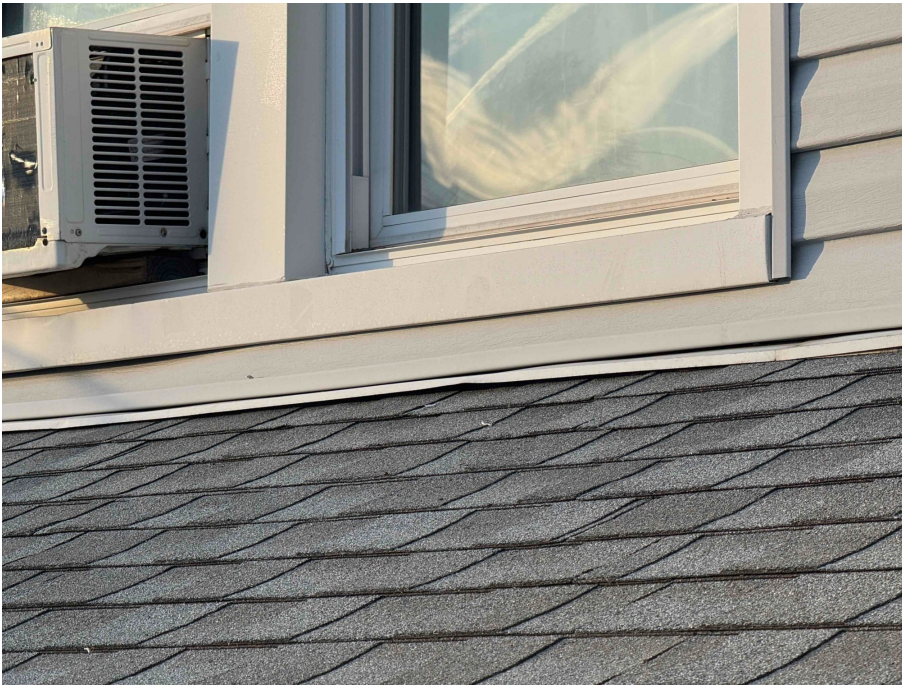
PHOTO 3 OF 7: PJFitzpatrick1.jpg

**Primary Damage Location:** Roof-to-wall interface below the window.

**Mechanism(s):**

Predominant: Wind uplift

Secondary: Wind-driven rain

**Evidence:**

- Distorted trim/flashing at the roof-to-wall interface.
- Out-of-plane elevation and bowing of the trim/flashing.
- Visible gap/separation between the trim/flashing and the wall.

Conclusion: Observed conditions are most consistent with Wind uplift associated with loading, based on distorted trim/flashing, out-of-plane elevation, and visible gap/separation, as reflected in localized deformation across the roof-to-wall interface.

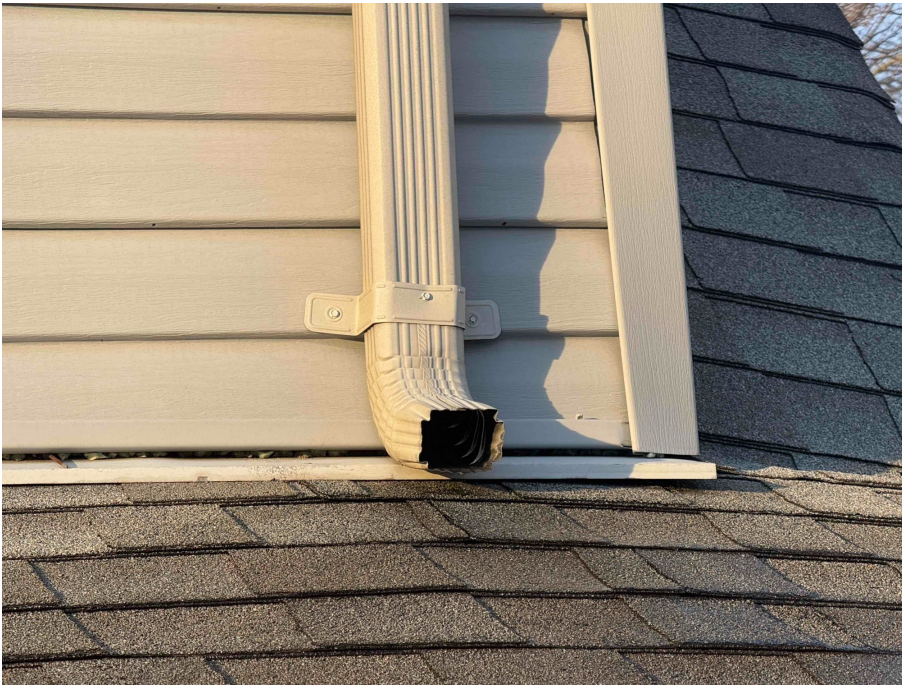
PHOTO 4 OF 7: PJFitzpatrick5.jpg

**Primary Damage Location:** Roof-to-wall interface at the downspout termination

**Mechanism(s):**

Predominant: Wind uplift

Secondary: Wind-driven rain

**Evidence:**

- Visible separation and out-of-plane displacement of the vertical trim piece from the roof surface at the roof-to-wall interface.
- Observable gap between the bottom edge of the wall siding and the roof shingles.
- Localized granule loss on shingles directly below the downspout discharge point.

Conclusion: Observed conditions are most consistent with Wind uplift associated with loading, based on visible separation and out-of-plane displacement of the vertical trim piece from the roof surface, as reflected in localized deformation at the roof-to-wall interface.

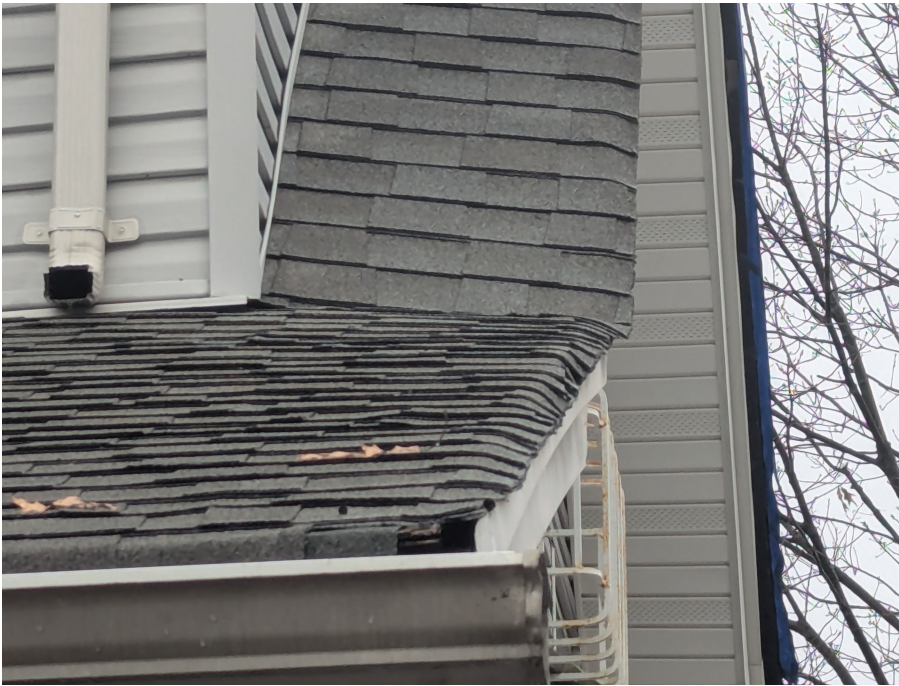
PHOTO 5 OF 7: PXL\_20251219\_161036692.jpg

**Primary Damage Location:** Lower roof eave and upper roof rake

**Mechanism(s):**

Predominant: Wind uplift

Secondary: Wind-driven rain

**Evidence:**

- Exposed sheathing/underlayment due to missing shingles.
- Out-of-plane shingle elevation and displacement along roof edges.
- Step-pattern (zippering) of shingle courses along roof edges.

Conclusion: Observed conditions are most consistent with Wind uplift associated with loading, based on exposed sheathing, out-of-plane shingle elevation, and step-patterning, as reflected in distributed displacement across the lower roof eave and upper roof rake.

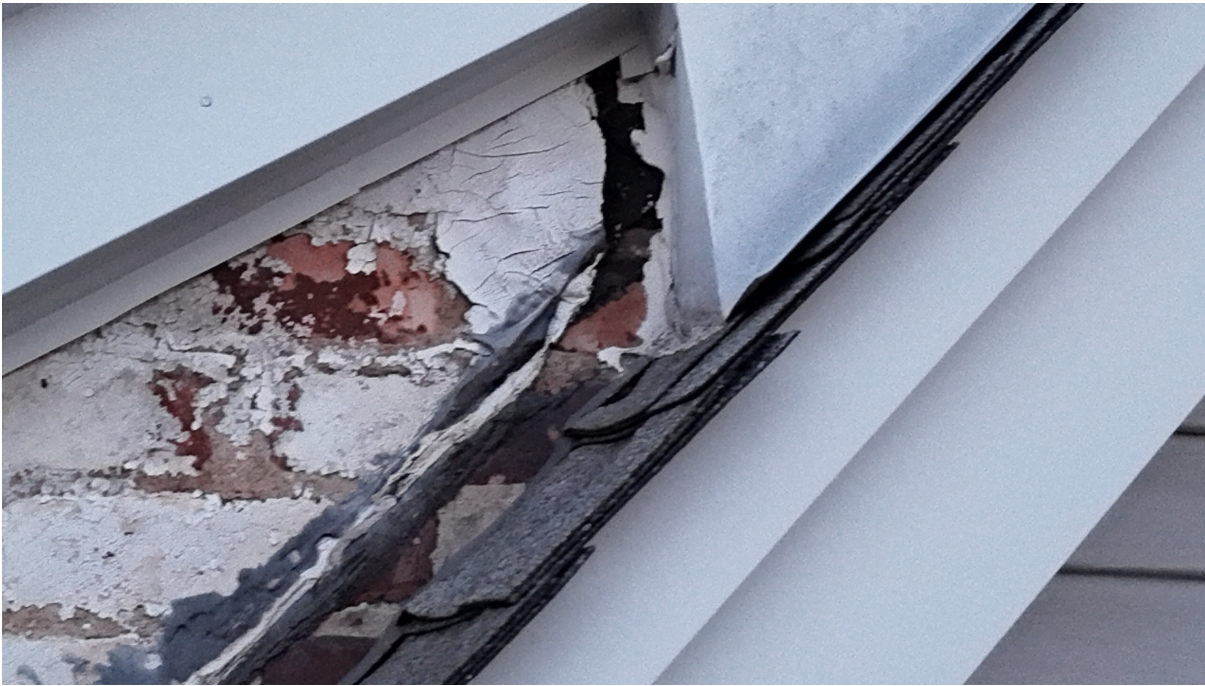
PHOTO 6 OF 7: DJI\_20260214212027\_0019\_D.JPG

**Primary Damage Location: Roof-to-wall interface****Mechanism(s):**

Predominant: Wind uplift

Secondary: Wind-driven rain

**Evidence:**

- Exposed sheathing at the roof-to-wall interface.
- Displaced shingles with out-of-plane elevation at the roof-to-wall interface.
- Visible gap and separation between the roof system and the adjacent wall/trim.

Conclusion: Observed conditions are most consistent with Wind uplift associated with loading, based on exposed sheathing, displaced shingles with out-of-plane elevation, and a visible gap at the interface, as reflected in localized deformation across the roof-to-wall interface.

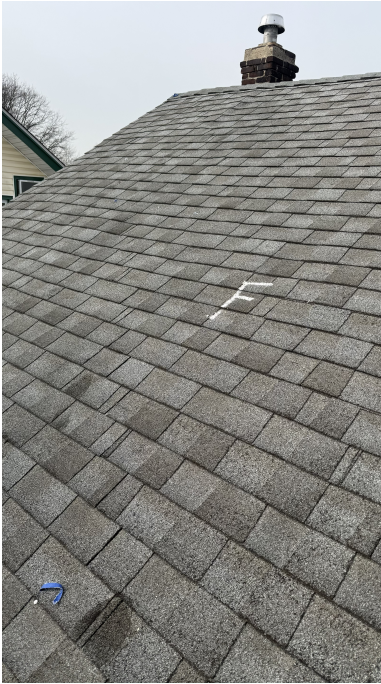
PHOTO 7 OF 7: IMG\_20260207\_110457.jpg

**Primary Damage Location: Roof field****Mechanism(s):**

Predominant: Wind uplift

Secondary: Bond failure

**Evidence:**

- Out-of-plane shingle elevation (tenting/lifting)
- Distributed shingle displacement
- Bond-line separation of shingle tabs

Conclusion: Observed conditions are most consistent with Wind uplift associated with loading, based on out-of-plane shingle elevation and bond-line separation, as reflected in distributed shingle displacement across the roof field.
